A Picture Is Worth

STITT®
SPARK PLUG COMPANY

Many times an engine problem can be solved by carefully examining its spark plugs for visual clues to abnormal conditions that may exist in the engine's power cylinders.

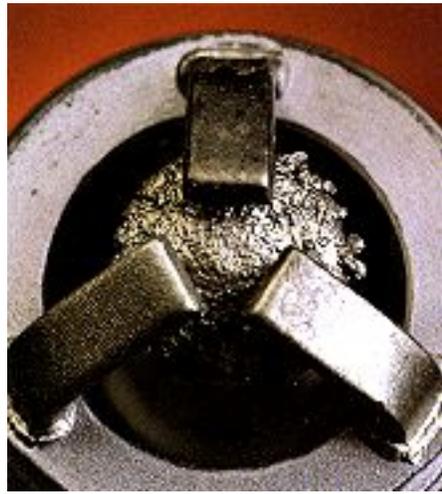
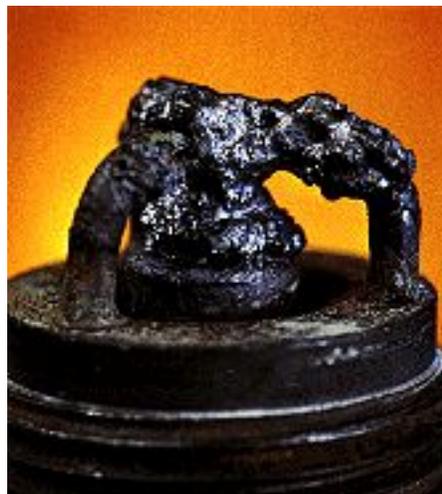
Molten center electrode or melted ground electrodes and center electrode. Possibly fractured and melted ceramic. Occasionally, melted steel shell.

PRE-IGNITION/DETONATION.

A melted nickel center electrode and/or melted ground electrodes always indicate that the spark plug has encountered higher than normal operating temperatures. Since the melting temperature of nickel is 2600°F, melting nickel indicates that the spark plug has probably been a victim of sustained pre-ignition or detonation. Check engine timing, mixture controls, and all engine functions.

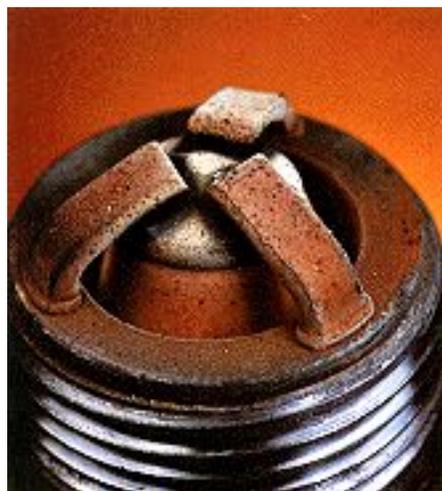
Red, grainy deposits on insulator nose and firing-end.

IRON OXIDE DEPOSITS.

Firing-end deposits of iron-oxide may prevent the discharge of energy across the spark gap. These iron oxide deposits usually indicate that there may be corrosion in the fuel gas line or the main transmission pipeline. If the engine has cylinder injection air starters, corrosion may also be found there. Lastly, iron oxide deposits may indicate a cracked cylinder head.

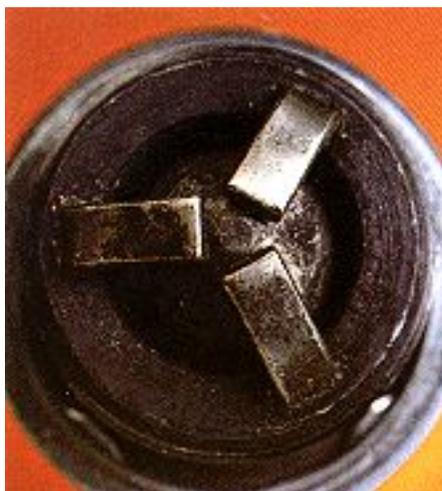
Black, fluffy deposits on firing-end.

CARBON DEPOSITS. Fluffy black carbon deposits usually indicate too rich a fuel/oxygen mixture. If a change in the mixture to a leaner setting fails to remedy this carbon fouling, try using Stitt's next hotter heat range spark plug.

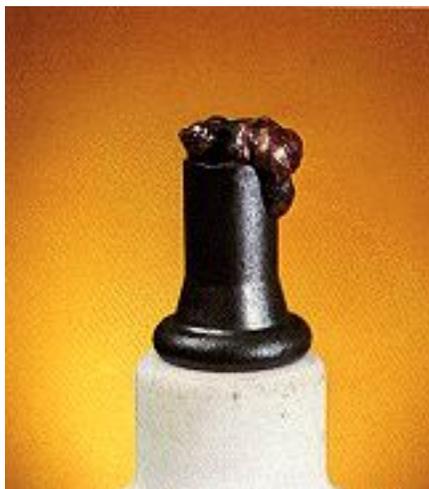
Copper deposits on center electrode, possibly bridging spark gap to ground electrode(s).

COPPER RUN-OUT. If spark plugs with copper in the center electrode operate at excessively high temperatures, copper run-out generally occurs when the center electrode temperature has exceeded 1900°F, a temperature much higher than the design-intended operating temperature of the electrode. This run-out of copper almost always shorts out the spark plug by bridging the spark gap. Check all engine functions that can prevent spark plugs from operating within their design-intended temperature range. Check to determine if too hot a heat range spark plug has been used in a high output engine. Or perhaps too much or too little installation torque has caused this problem. If so, make sure that spark plugs are being installed with an indicating torque wrench to the spark plug manufacturer's recommendations. Pre-ignition may also be indicated when copper runout is observed with ignition too far advanced or mixture too lean. To extend the spark plug's temperature range, consider the substitution of spark plugs with electrodes of solid nickel, which will extend temperature limit of center electrode to 2800°F before melting occurs.
